## **SERVICE BULLETIN**

# <sub>N°</sub> 169-148

#### ATA 64 - TAIL ROTOR FLIGHT CONTROL IMPROVED PERIODICAL INSPECTION

This Service Bulletin is issued in order to require the periodical inspection of the slippage marking of the back-end castellated nut of the TR servo-actuator and the periodical detailed inspection of the TR duplex bearing.

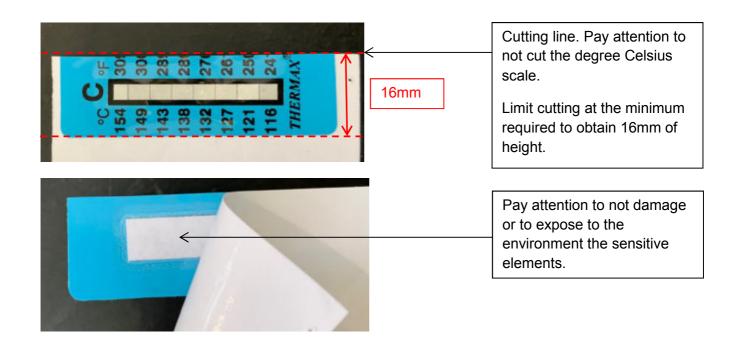
Do not use a thermal strip if after having trimmed it, its sensitive element is exposed to air. See below an example of a badly cut strip.
